**Flood Control Project Maintenance
Levee Inspections**

Maintenance Issue Types Only, Levee Inspection Report By Mile - Spring 2015

Reclamation District No. 1601 Twitchell

Waterway	Bank	Unit Miles	Inspection Start/End	Inspector
Unit No. 01 Threemile Slough	Left	2.43	04/08/2015 04/08/2015	Richard Willoughby

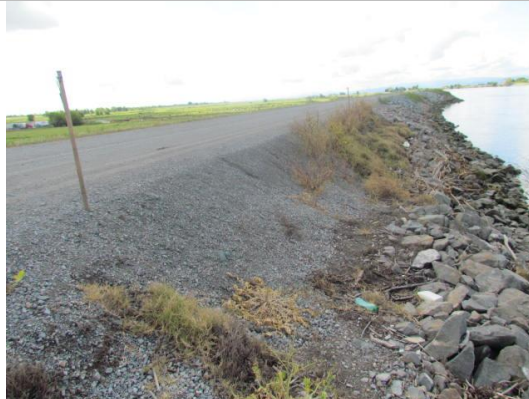
Photo 1 of 2 : SP_2015_RD1601_237_14_20150409_00004.jpg

LM Start	0.99	Rating **	M	Issue No.	14
LM End	1.00	Issue Type +	Ma	Location *	WS
Category	Earthen Levee			GPS Latitude/Longitude	
				Start	End
Item	Slope Stability			38.108265 °	38.108115 °
				-121.682747 °	-121.682804 °
DWR ID	DWR_RD1601_01_s _ 2015_14				
Action/Comments					
Repair slope instability. Inspector Comments: Slight caving was observed on waterward shoulder and slope.

Looking southeast at slope depression/caving at waterward shoulder and slope.

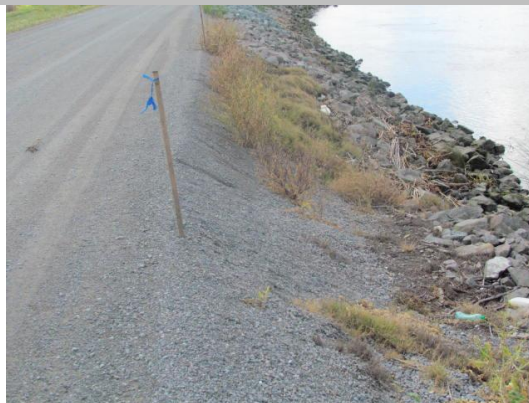
Photo 2 of 2 : SP_2015_RD1601_237_14_20150409_00003.jpg

LM Start	0.99	Rating **	M	Issue No.	14 (cont)
LM End	1.00	Issue Type +	Ma	Location *	WS

Looking south at slope depression/caving at waterward shoulder and slope.

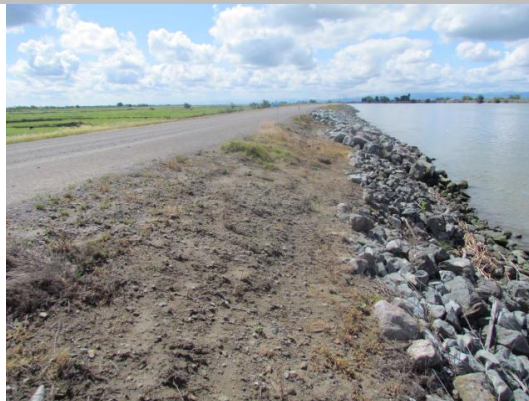
Photo 1 of 2 : SP_2015_RD1601_237_15_20150409_00005.jpg

LM Start	1.27	Rating **	M	Issue No.	15
LM End	1.28	Issue Type +	Ma	Location *	WS
Category	Earthen Levee			GPS Latitude/Longitude	
				Start	End
Item	Slope Stability			38.104340 °	38.104114 °
				-121.683890 °	-121.683933 °
DWR ID	DWR_RD1601_01_s _ 2015_15				
Action/Comments					
Repair slope instability. Inspector Comments: Slight caving observed on waterward shoulder and slope.

Looking south at depression/caving on waterward shoulder and slope.

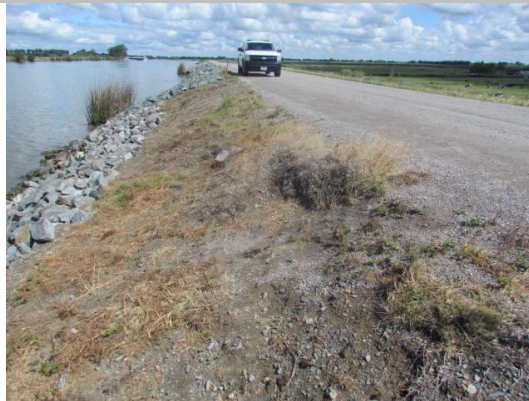
Photo 2 of 2 : SP_2015_RD1601_237_15_20150409_00006.jpg

LM Start	1.27	Rating **	M	Issue No.	15 (cont)
LM End	1.28	Issue Type +	Ma	Location *	WS
Category	Earthen Levee			GPS Latitude/Longitude	
				Start	End
Item	Slope Stability			38.104340 °	38.104114 °
				-121.683890 °	-121.683933 °
DWR ID	DWR_RD1601_01_s _ 2015_15				
Action/Comments					
Repair slope instability. Inspector Comments: Slight caving observed on waterward shoulder and slope.

Looking north at depression/caving on waterward shoulder and slope.
